**EPA CONTRACT NO: 68HE0319D0004**  
**TD No: TO-0036-0017**  
**DC No: STARTV-02-F-0074**  
**SUBJECT: FINAL REMOVAL ACTION REPORT, RV1**  
**NIAGARA FALLS BOULEVARD SITE,**  
**NIAGARA FALLS, NIAGRA COUNTY, NEW YORK**

# **FINAL REMOVAL ACTION REPORT, RV1**

## **NIAGARA FALLS BOULEVARD SITE**

Niagara Falls, Niagara County, New York

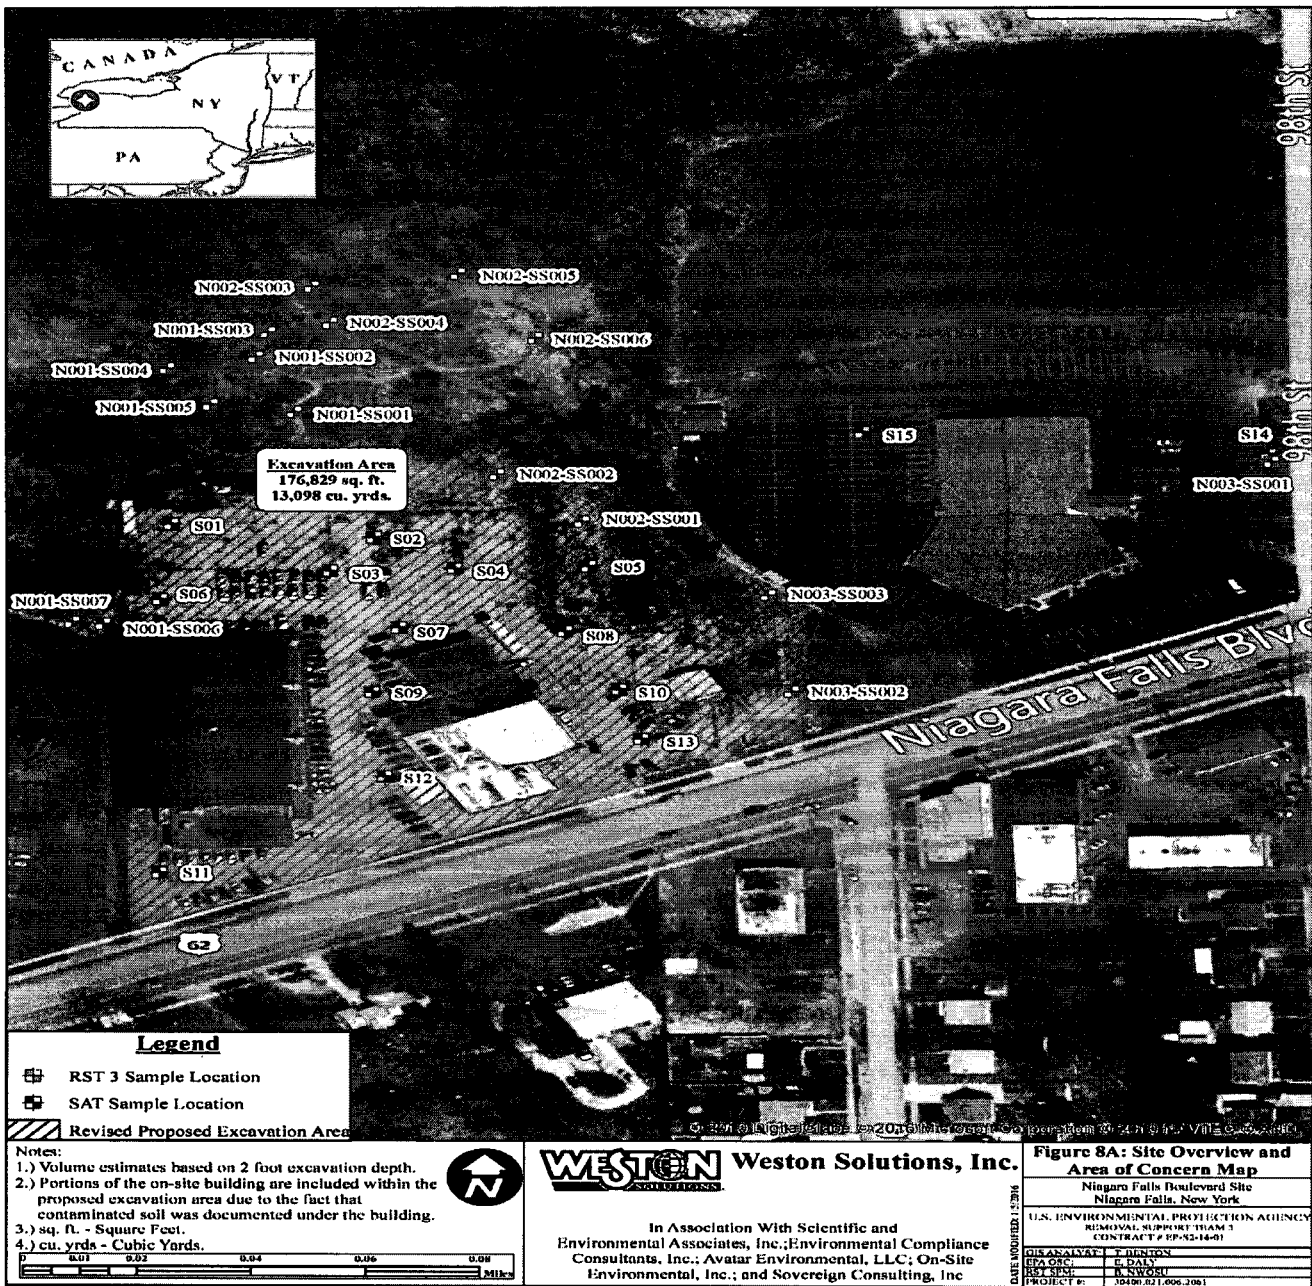
# Attachment E: Proposed Excavation Area

- d. Exterior Contamination: EPA Pre-Remedial and EPA Removal Programs observed the radioactive top fill layer to generally range in thickness from 0.5–2 feet. The footprint of the contamination area of concern is approximately 176,829 square feet. The approximate amount of contaminated material to excavate is 13,098 cubic yards. See Attachment E for map of proposed excavation area.

- g. The excavated material will be replaced with certified clean fill. Certified clean fill is soil that has been analyzed for Ra-226 and Ra-228, with results indicating that the concentration is at or below the established cleanup values and that all other hazardous substances and pollutants are at acceptable levels. Areas currently asphalted, concreted, sodded, or graveled over, will be replaced with asphalt, concrete, sod, or gravel, accordingly.

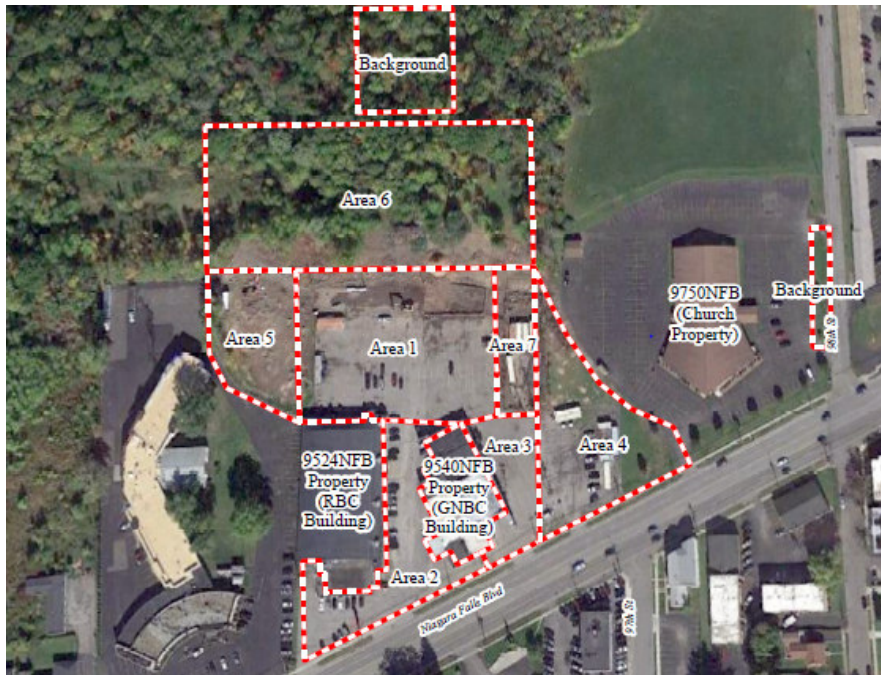
**Photograph 1:** The U.S. Environmental Protection Agency, Region II (EPA) with the support of its Removal Support Team 3 (RST 3) and Emergency and Rapid Response (ERRS) contractors conducted a Removal Action (RV1) at the Niagara Falls Boulevard Site (the Site). The Site consists of two parcels, 9524 and 9540 Niagara Falls Boulevard (NFB). 9524NFB is operated by Rapids Bowling Center (RBC) and 9540NFB is occupied by a hardware store, Greater Niagara Building Center, Inc. (GNBC). The First Assembly Church property (the Church Property) on 9750NFB was utilized for background sampling and data reference.

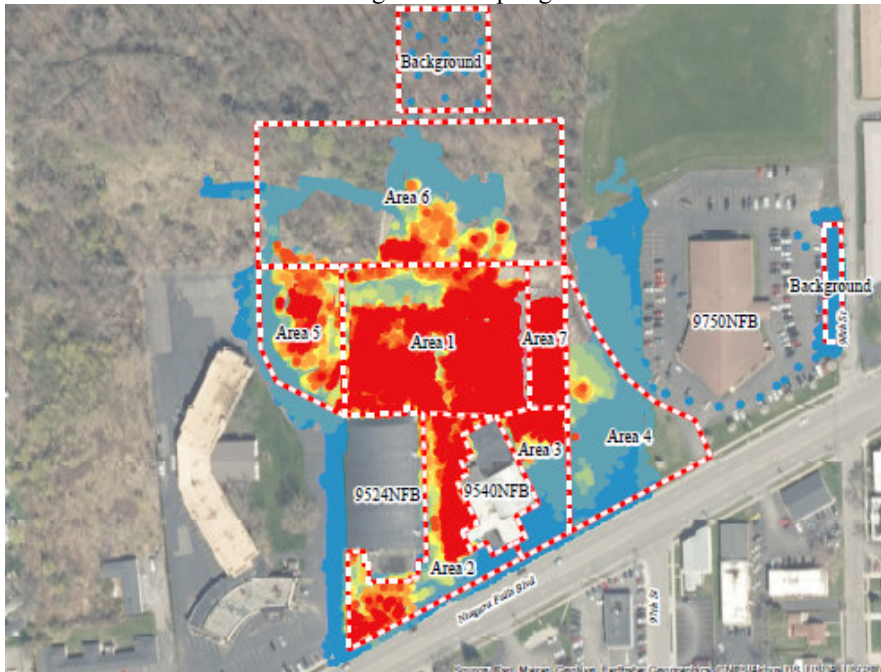
**Photograph 2:** Based on radiological survey data and for the purpose of executing RV1, the Site was divided into exterior areas of concern (AOCs) identified as Area 1 through Area 7 and interior AOCs were identified in 9540NFB GNBC building.

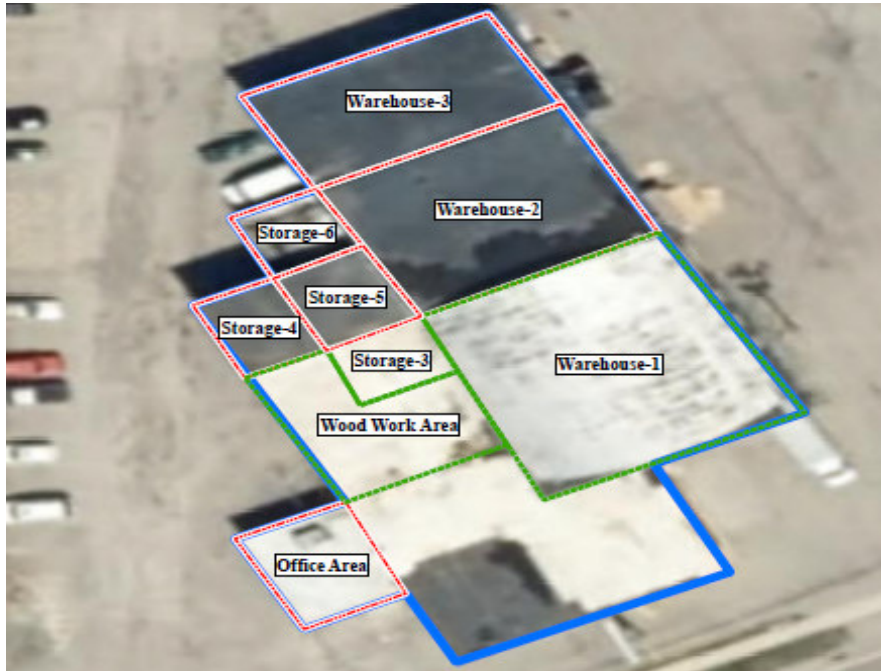
**Photograph 3:** For the purpose of executing RV1, the interior AOCs in the GNBC building were identified to include the GNBC Office Area, storage areas located in the rear of the GNBC building including Storage-4 (ST-4), portions of Storage-5 (ST-5), and Storage-6 (ST-6); and warehouse areas including Warehouse-2 (WH-2) and Warehouse-3 (WH-3).

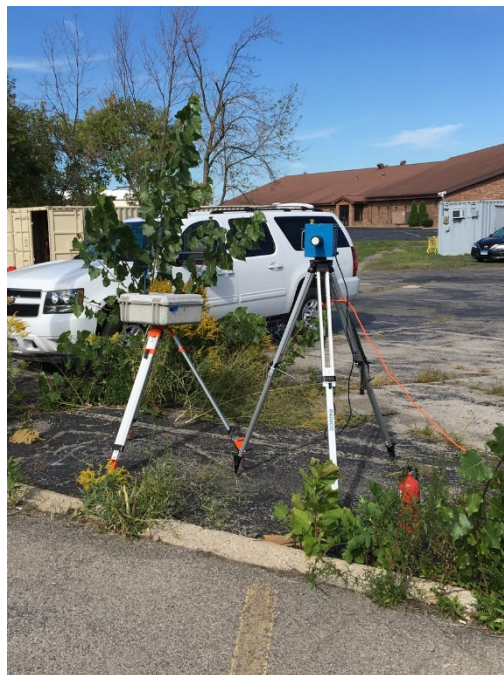
**Photograph 4:** Prior to initiating removal activities at the Site, RST 3 performed baseline perimeter monitoring for PM<sub>10</sub> (particulate matter smaller than 10 microns) using DustTrak particulate monitors and community air sampling using RADēCO volumetric air samplers. On a daily basis during removal activities in both interior and exterior AOCs, perimeter air monitoring and sampling was conducted.

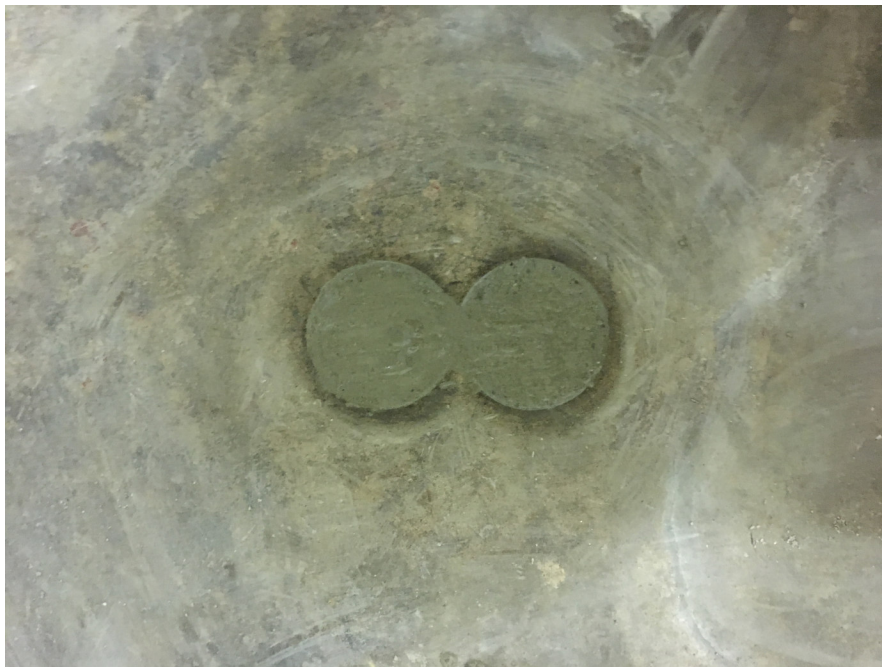
**Photograph 5:** Core drilling was performed at locations selected by the EPA On-Scene Coordinator (OSC) in GNBC ST-3, GNBC ST-4, GNBC ST-5, GNBC Woodwork Area (WA), and the Church Property utility building from which concrete samples were collected. Locations where core drilling was performed were sealed after collecting concrete sampling.

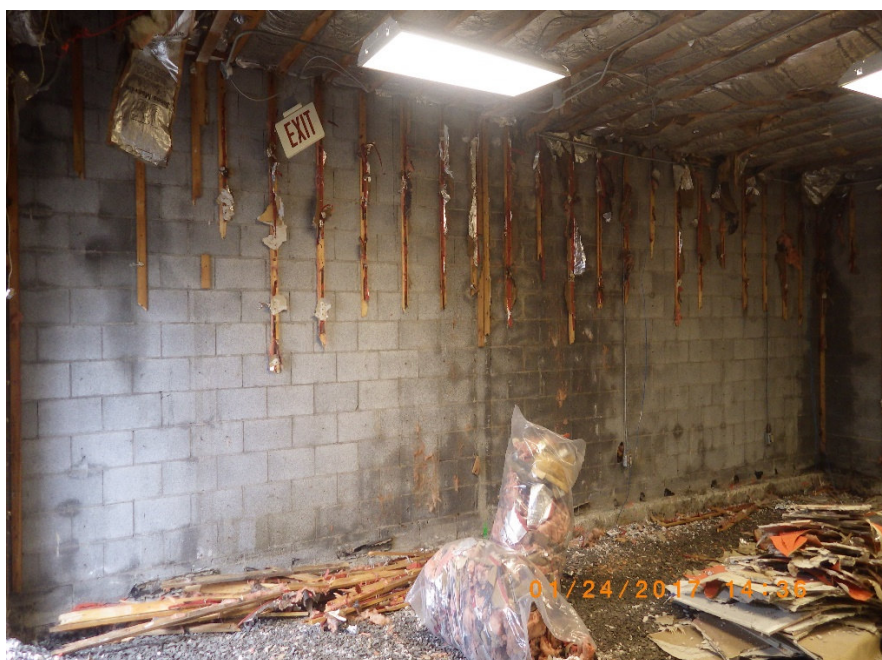
**Photograph 6:** View of the demolition in the GNBC Office Area prior to excavation. Structural deficiencies that were not building-code compliant were addressed before commencing excavation activities.

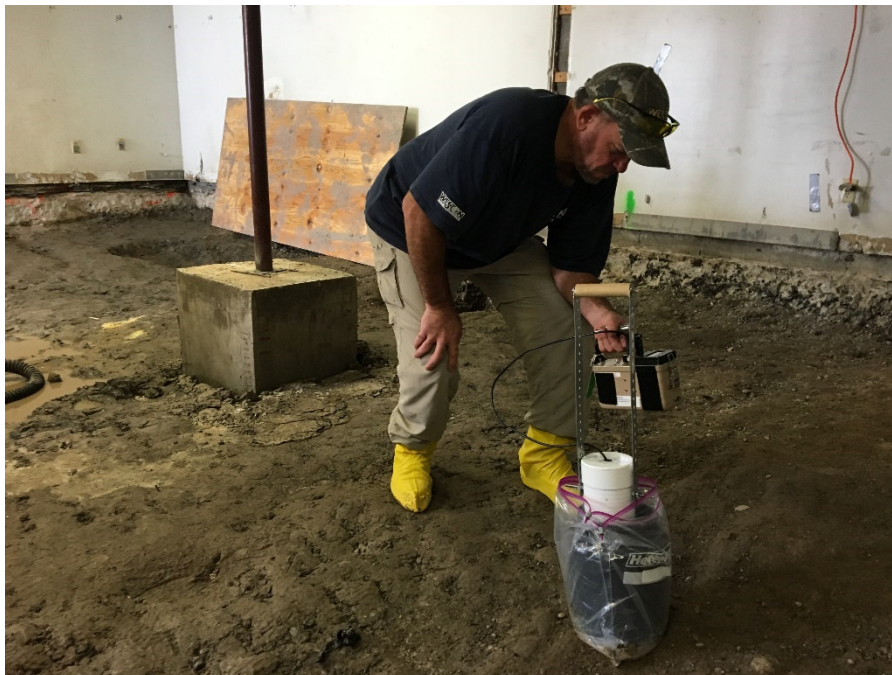
**Photograph 7:** The GNBC Office Area concrete floor was cut, removed from area, and scanned for radioactivity using Ludlum-2241 and 3x3 sodium iodide (NaI) scintillator.

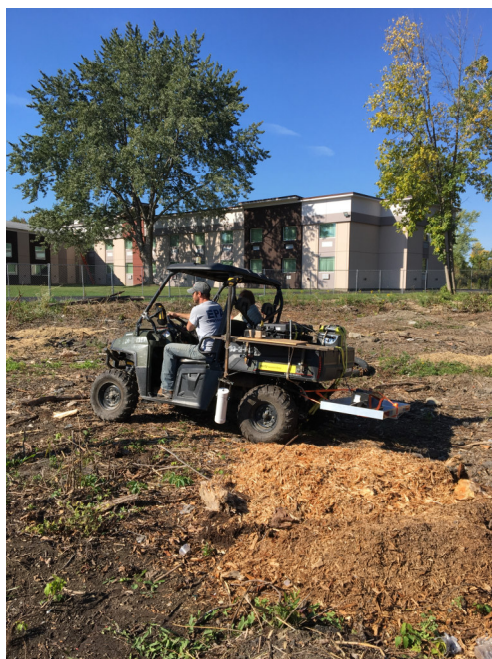
**Photograph 8:** The ERRS contractor completed clearing and grubbing of vegetation at selected areas for staging the command post and office trailers, following which RST 3 conducted gamma survey of the cleared areas as well as the entire parking lot areas and Area 5. Gamma survey was conducted utilizing Ludlum-2241 and 3x3 NaI scintillator, which were mounted on an All-Terrain Vehicle (ATV) and connected to the EPA VIPER system (a wireless network-based communications system) to provide instantaneous real-time gamma readings through a computer server.

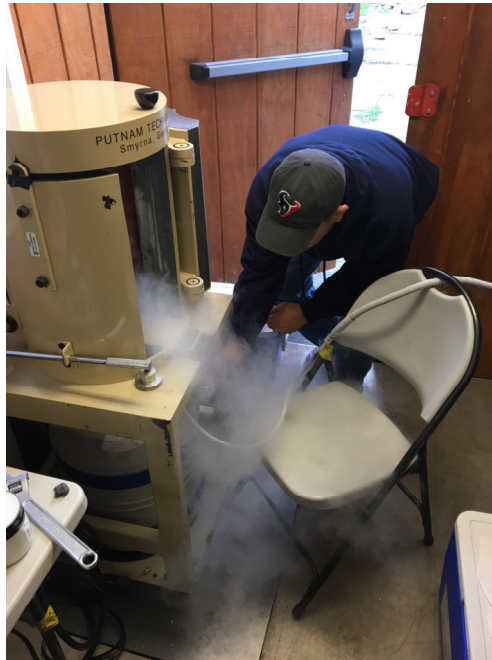
**Photograph 9:** View of RST 3 personnel filling the High-Pressure Germanium (HPGe) radiation detector with liquid nitrogen. The HPGe radiation detector was utilized on Site for soil sample analysis to determine the concentrations of radiological contamination for operational planning.

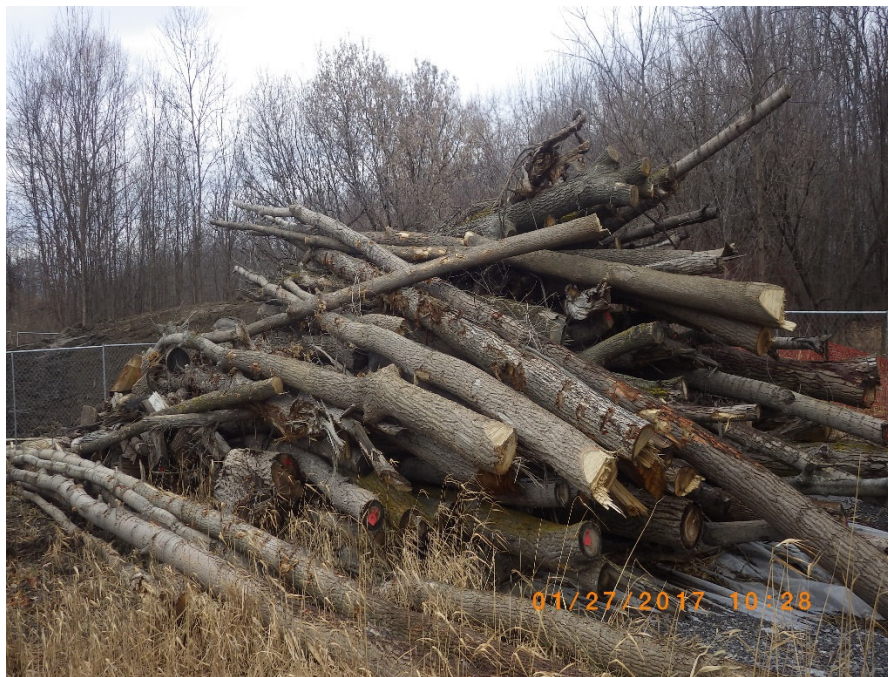
**Photograph 10:** Approximately 100 trees that were removed from Area 5 prior to excavation were assessed for off-site disposal. Prior to removing the trees, the coordinates of each tree was recorded using Global Positioning System (GPS) technology.

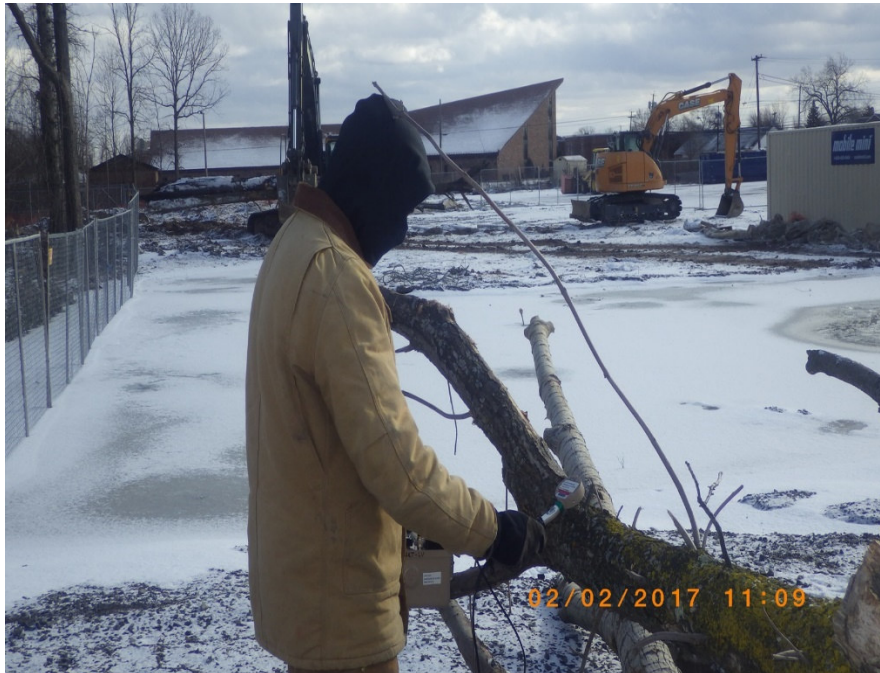
**Photograph 11:** The removed trees were assessed by scanning with Ludlum-3 and pancake probe and analyzing wood chips from the trees on-site using HPGe. Based on the assessment, it was determined that no radioactive material from Area 5 was taken up by the trees via the root system, absorbed into the trees, or adhered to the exterior of the trees. Subsequently, a local farmer opted to utilize them and began gradual removal of the tree trunks to his farm.

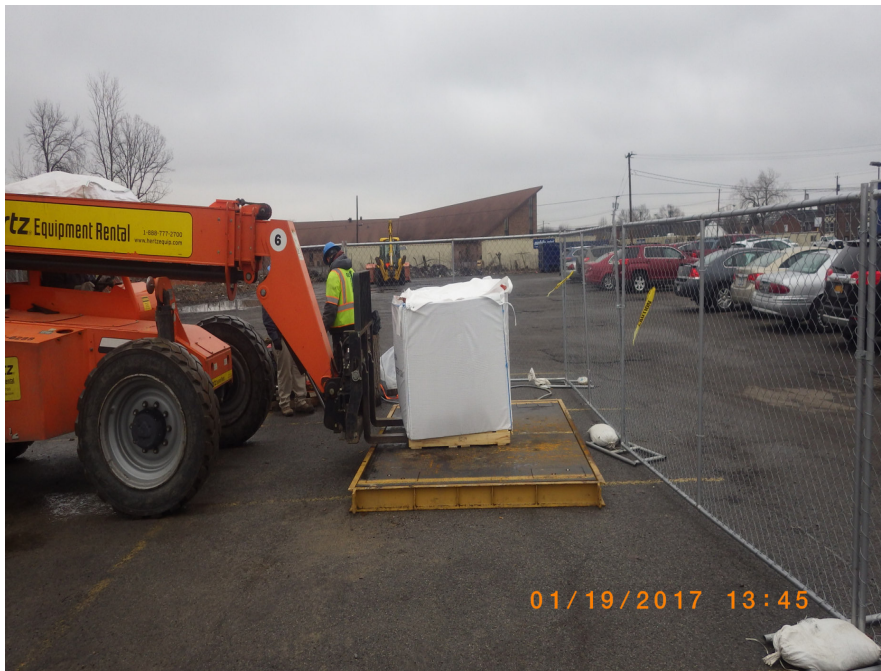
**Photograph 12:** View of a super sack containing contaminated soil being weighed in preparations for off-site transportation for disposal.

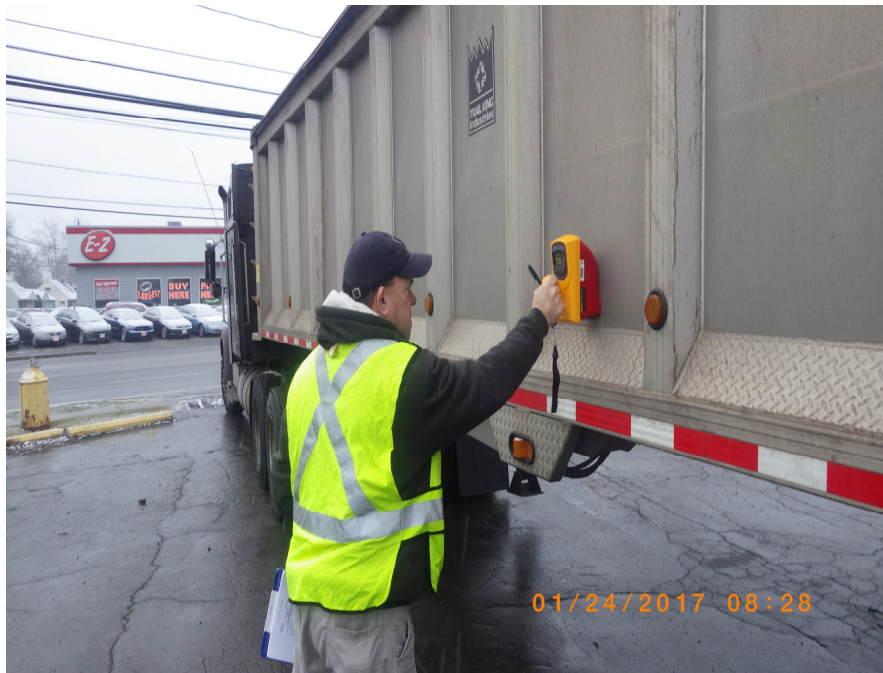
**Photograph 13:** All waste disposal trucks and trailers were scanned with Ludlum-2241 and 2x2 NaI Scintillator, and subsequently a Fluke Pressurized Ionization Chamber (FPIC) was utilized to perform confirmation screening of the trucks and trailers prior to departing the Site in order to ensure that the waste acceptance criteria (WAC) of the disposal facility was met.

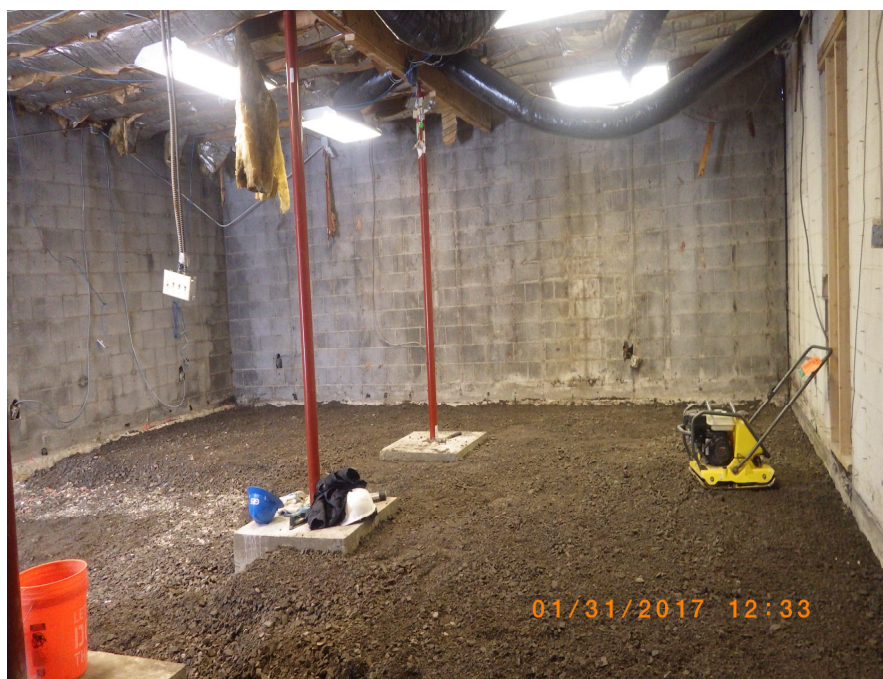
**Photograph 14:** View of backfilled portion of the GNBC Office Area after excavation of contaminated soil.

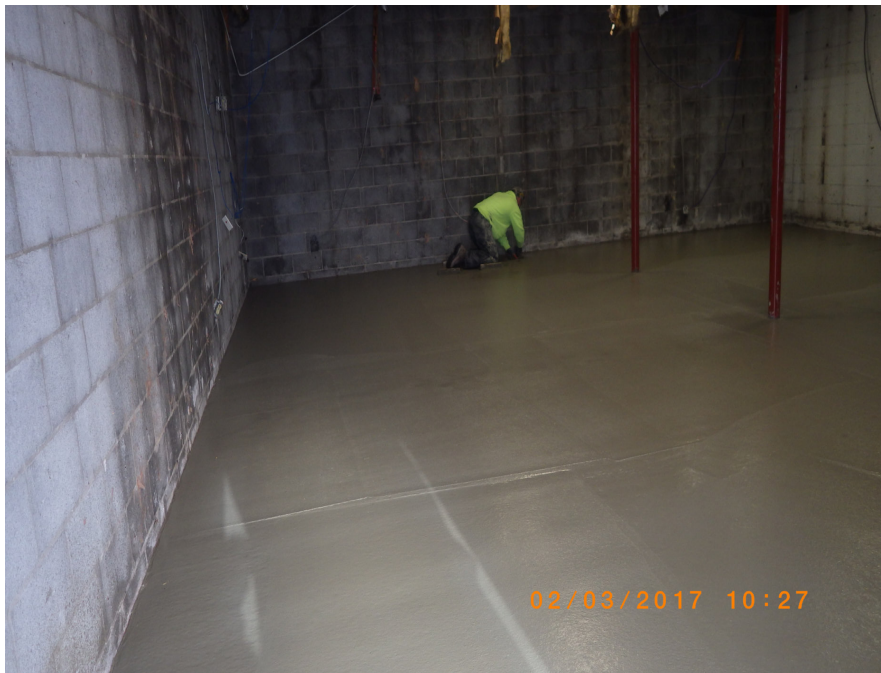
**Photograph 15:** View of ERRS personnel completing finishing touches to the new concrete floor slab in GNBC Office Area.

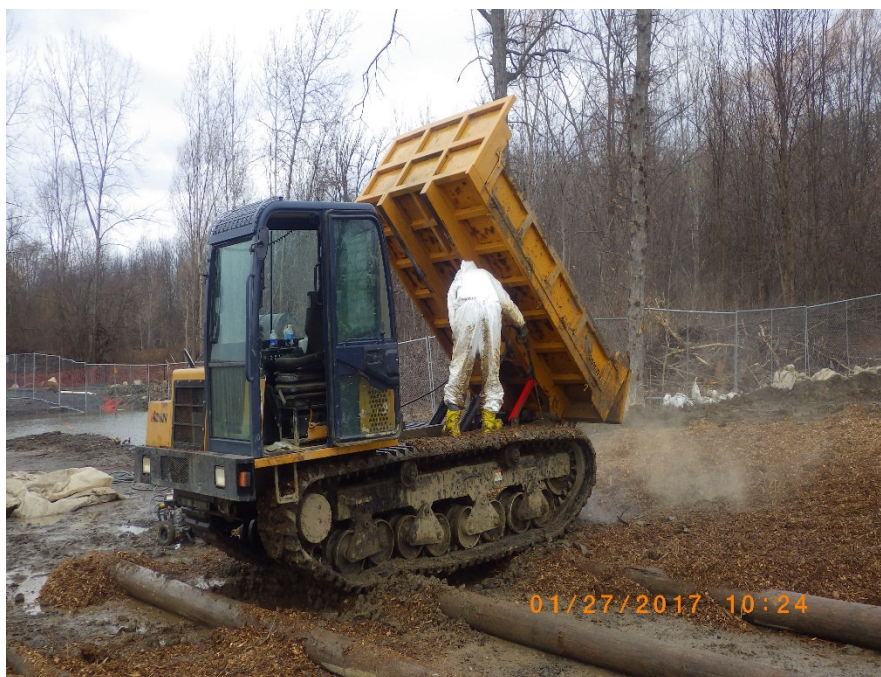
**Photograph 16:** View of ERRS personnel decontaminating a track dump truck (Morooka MST-800VD) prior to being demobilization from Site. Wipe samples were collected from all equipment after decontamination and analyzed on-site using Ludlum-3030 to verify that the equipment did not have any residual radiological material prior to leaving the Site.

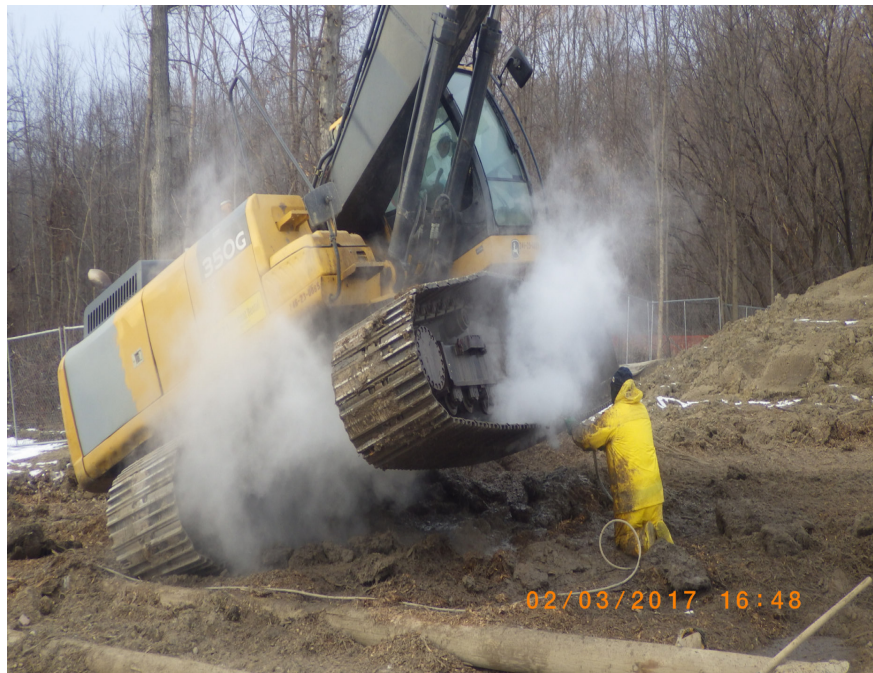
**Photograph 17:** View of ERRS personnel conducting decontamination operations on a 350G excavator.

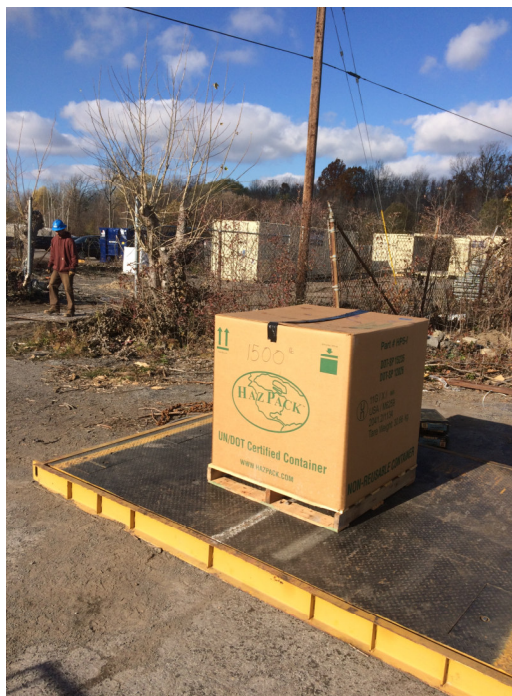
**Photograph 18:** View of a cubic yard box containing contaminated soil being weighed in preparations for off-site transportation for disposal.

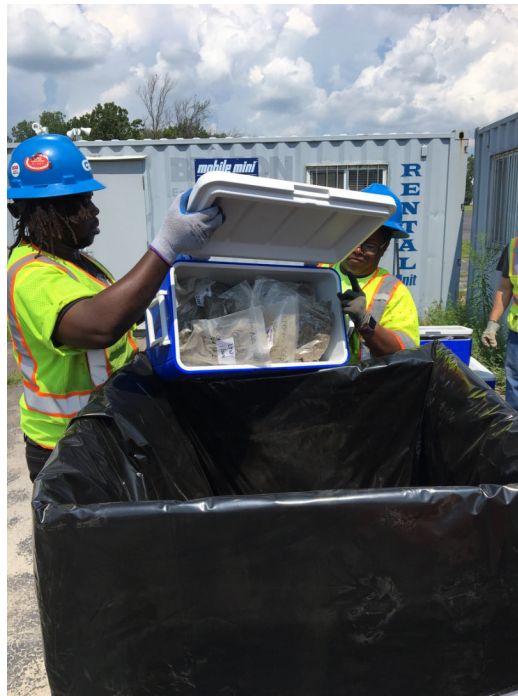
**Photograph 20:** View of ERRS personnel consolidating leftover soil/slag samples from the May 2017 Removal Assessment sampling event into a lined super sacks. Approximately, 2.25 tons of leftover soil/slag sample material from the May 2017 Removal Assessment event was shipped off-site to US Ecology in Belleville, Michigan.

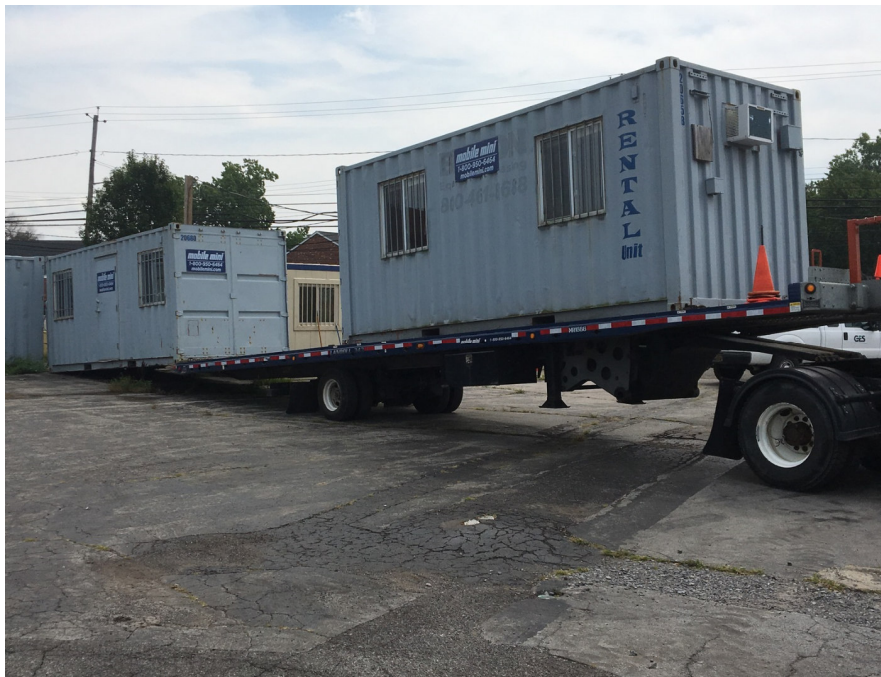
**Photograph 21:** At the end of RV1 operations, all Conex boxes and office trailers were emptied, cleaned, and gamma surveyed, and wipe samples collected and analyzed with Ludlum-3030. Based on wipe sample analytical results, all Conex boxes and office trailers were cleared for radiation and removed off-site.

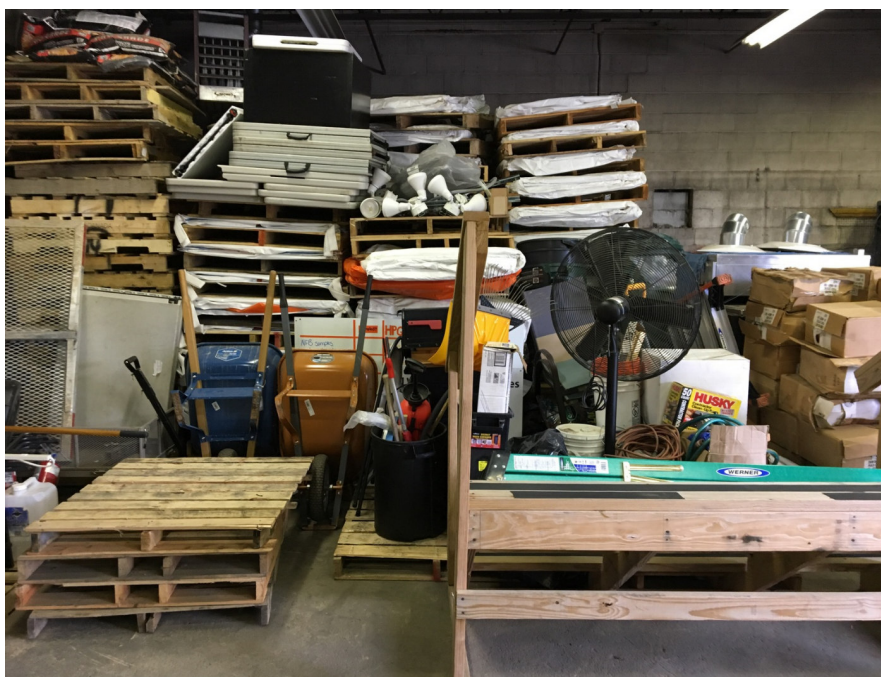
**Photograph 22:** View of leftover supplies that were stored on-site in GNBC WH-3 after the completion of RV1 activities. Due to funding limitation, EPA discontinued removal operation at the Site on July 13, 2017, with a view to continue work at the Site in the Spring of 2018.
